**2012 Annual Inspection Report**

**BRADY CANAL HYDROLOGIC  
RESTORATION PROJECT (TE-28)**

State Project Number TE-28  
Priority Project List 3

July 15, 2012  
Terrebonne Parish

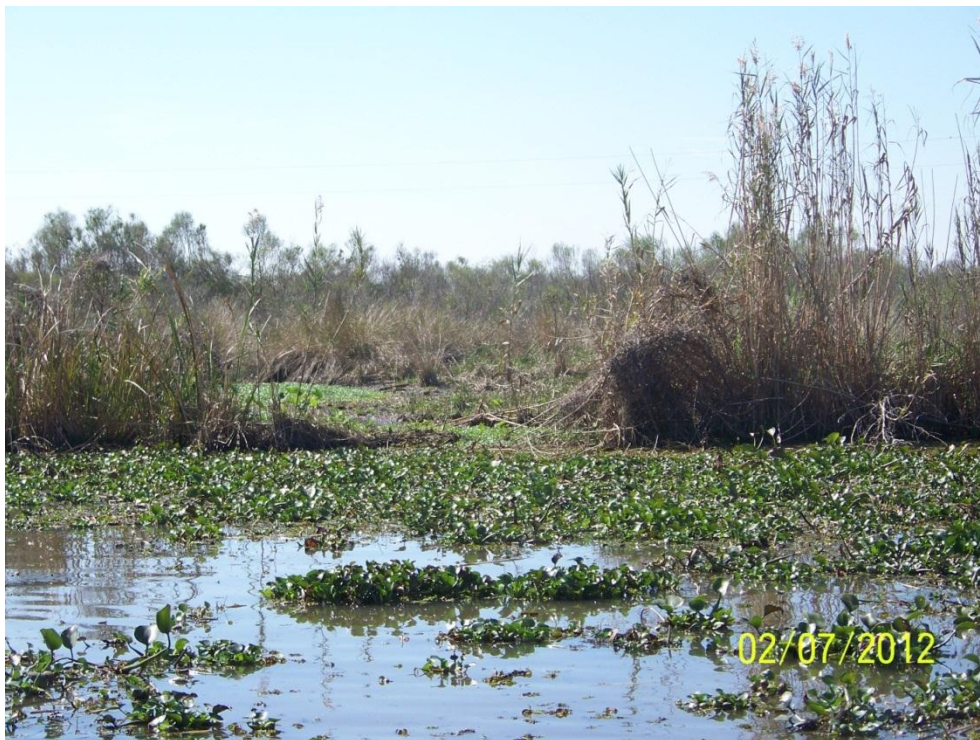
Photo #56: View of a breach identified during the 2012 annual inspection. Location in Bayou Carencro close proximity to point N29 24m 32.1s, W90 59m 05.6s
